# Fourteen Mile Creek/Goose Creek-OH River Watersheds Improvement Project

## WATERSHED MANAGEMENT PLAN

Fourteen Mile Creek/Goose Creek-OH River Watersheds Improvement Project  
9608 Highway 62  
Charlestown, IN 47111  
(812) 256-2330, ext. 3

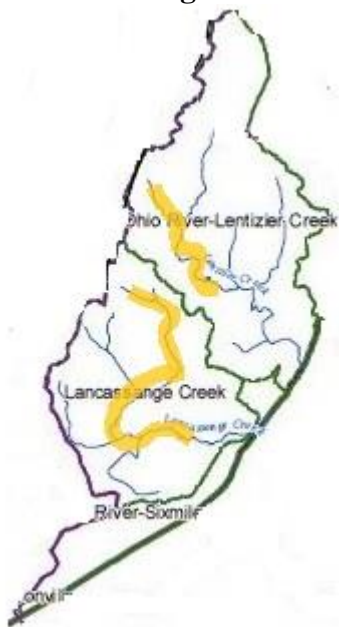
**Figure 94: Lentizier Creek Subwatershed Stream Banks Needing Buffers**

The desktop survey completed during this project to determine stream miles in need of buffers, identified 3.61 miles of stream banks in this subwatershed that could benefit from the installation of buffers. These are not continuous miles, but are scattered along the stream systems. Figure 94 represents these miles.
